MASSACHUSETTS DEPARTMENT OF ENVIRONMENTAL PROTECTION

BACTERIA SOURCE TRACKING PILOT STUDY

Summary Report

November 2004

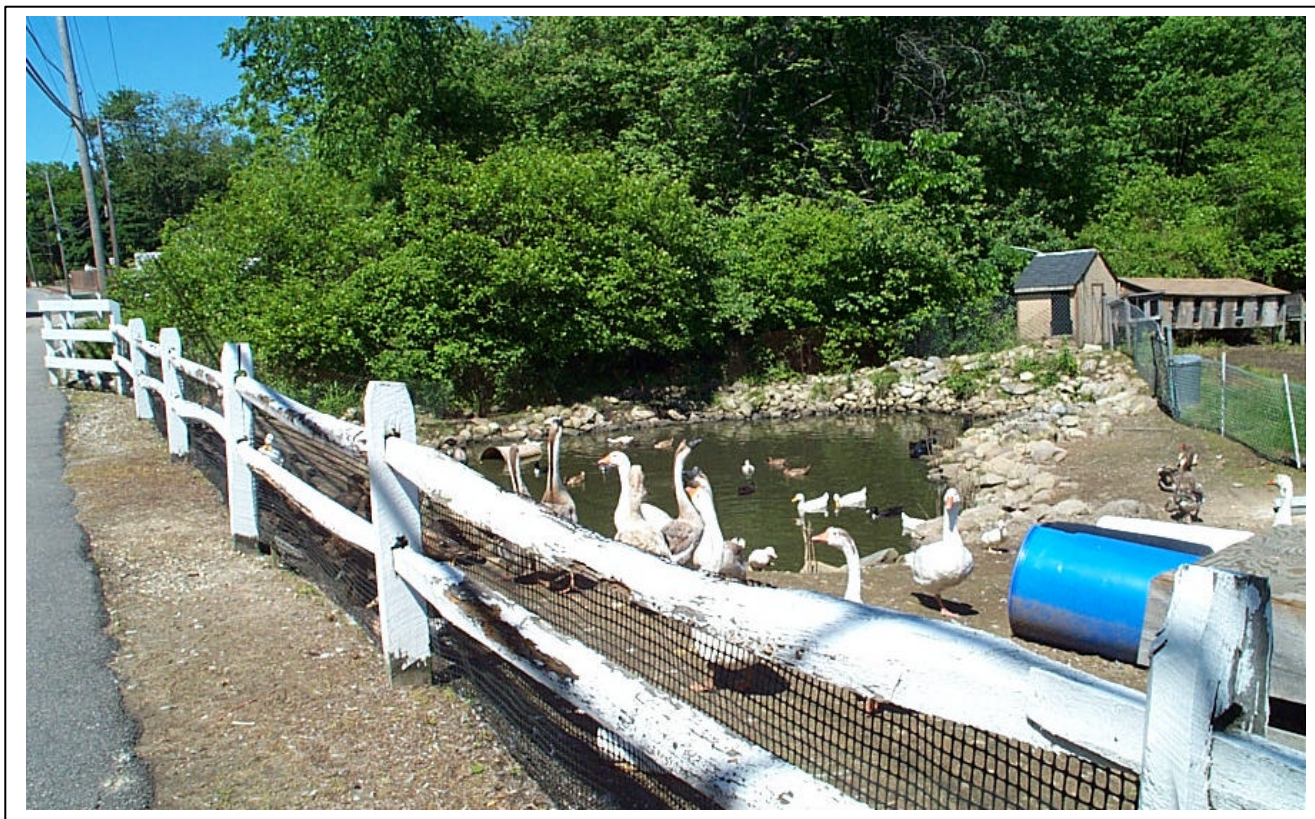
- *Arnolds Brook downstream from commercial animal pens – Figure 1. Pulaski Boulevard*
In the upper portion of Arnolds Brook, six sampling events occurred downstream from an animal pen property. Elevated E. coli bacteria counts were noted regardless of wet or dry weather. Bacteriodes samples were collected at this location to confirm non-human source of E. coli bacteria due to upstream concentrated animal lot. These results have not been reported to DWM.

Figure 1. Pulaski Boulevard - Commercial animal pens adjacent to Arnolds Brook.

Results: Elevated bacteria counts in Arnolds Brook near Pulaski Boulevard were attributed to runoff from commercial animal pens containing ducks, geese, chickens, pigs and goats that were located just upstream from the screening level sampling station. Negative optical brightener tests supported this conclusion.

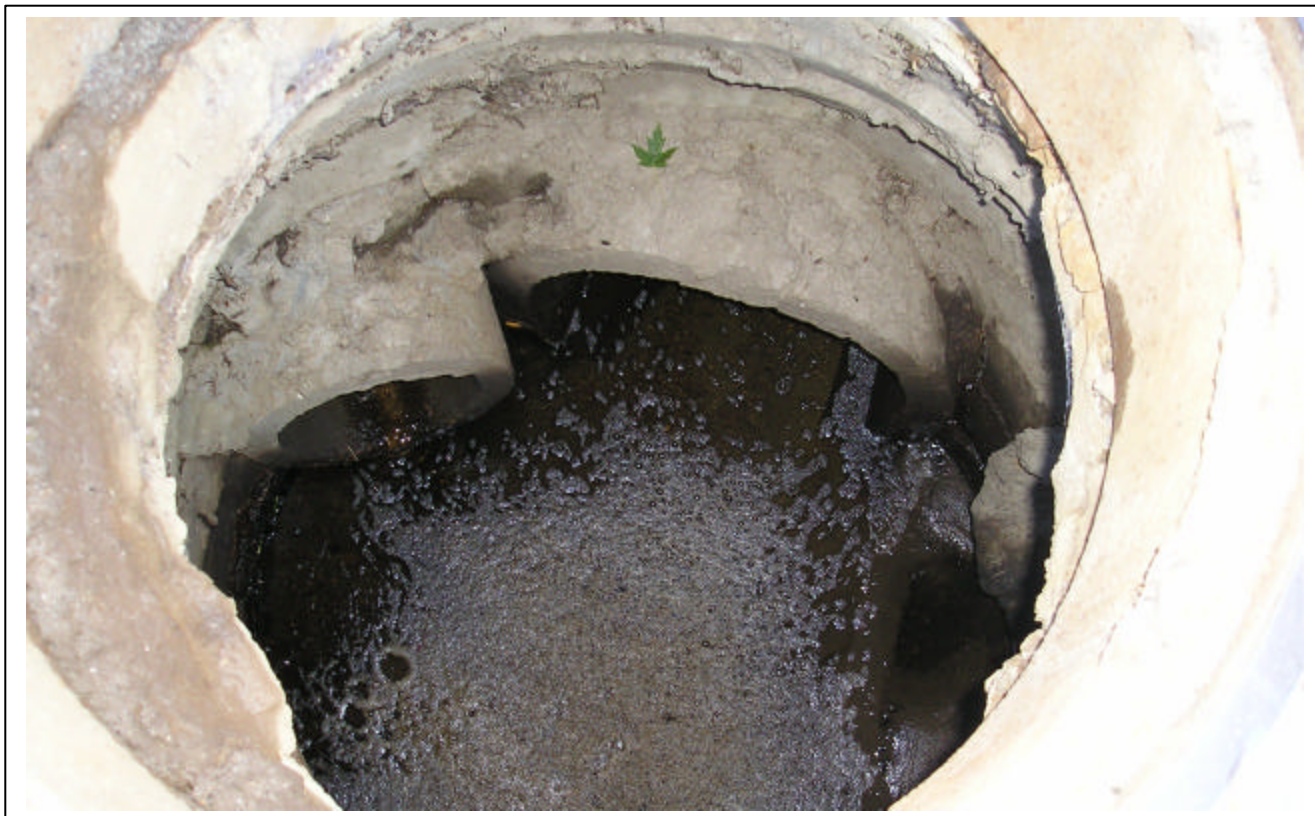
- *Stormwater outfall to Arnolds Brook – Figure 2. Lowland Street neighborhood*
In the lower portion of Arnolds Brook a stormwater outfall enters the stream upstream of its confluence with the Peters River. Samples were collected from this stormwater outfall on 12 occasions, half of which came back with elevated E.coli counts. Optical brightener (OB) pads were deployed at this location to determine the presence of fluorescent whitening agents (FWAs) – source from laundry detergents. A strong positive was observed from the OB pads collected at the outfall. DWM worked with the Bellingham Department of Public Works (DPW) to track the infiltration of laundry water to the storm sewer system in this area. Three rounds of storm sewer manhole sampling occurred to track the possible presence of illicit connections and/or failing septic systems. Nine manholes were sampled and one showed the presence of soapsuds and elevated E.coli bacteria counts. The DPW is continuing to track this storm sewer line with the use of a video camera – conclusion pending. The Public Health Department was also contacted regarding the status of septic systems in the area.

Figure 2. Lowland Street manhole - storm sewer system to Arnolds Brook - soapsuds.

Results: Source tracking activities located a stormwater pipe discharging to Arnolds Brook at Pine Grove Avenue that was contaminated with sewage presumed to be from an illicit discharge to the storm drain system from one or more residences in the upstream unsewered neighborhood. High *E. coli* bacteria numbers, combined with strong positive optical brightener results that confirmed the presence of laundry detergent, indicated that the bacteria were likely from human sewage input(s). Sewage fungus was also observed on the streambed below the stormwater pipe outfall.

Outcome: Frequent communication and cooperation with the Bellingham DPW was required to track the source of laundry water and sewage by intensively sampling the storm drains via manholes and bracketing suspected areas. Bellingham is continuing to survey the storm drain system using a video camera and has narrowed the source to within just a few residences.

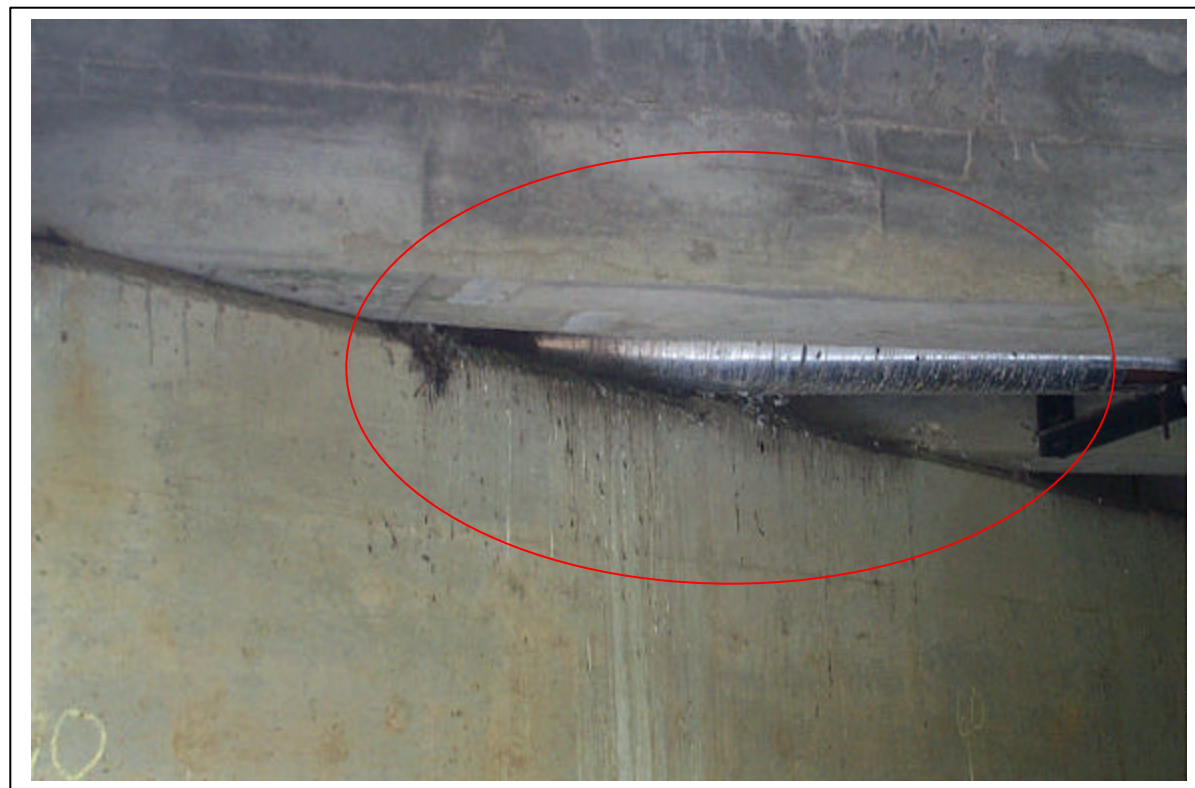
- *Lower Watershed of Peters River – Figure 3. Wrentham Road*
The most downstream sampling station on Peters River (sampled 14 times) showed consistent elevated E.coli bacteria counts regardless of wet or dry weather. 100 meters upstream of this sample location is a road crossing – samples were collected upstream and downstream of this road crossing on four occasions. On all occasions, samples collected downstream of the road crossing were higher than samples collected upstream. Upon further investigation, under the road crossing were gross amounts of pigeons, pigeon nests, and pigeon droppings. Bacteriodes samples were collected at this location to confirm non-human source of E. coli bacteria. These results have not been reported to DWM.

Figure 3. Wrentham Road – bird droppings.

Results: In the lower most section of the mainstem Peters River, *E. coli* counts were consistently elevated during both wet and dry weather. Stream walks and optical brightener testing did not indicate obvious potential human sources, however under an upstream bridge crossing, large

numbers of pigeons, pigeon droppings and bird nests were observed. *E. coli* counts measured upstream of the bridge were always lower than downstream of the bridge, so elevated counts in this section of the Peters River were presumed to be, at least in part, from the birds.

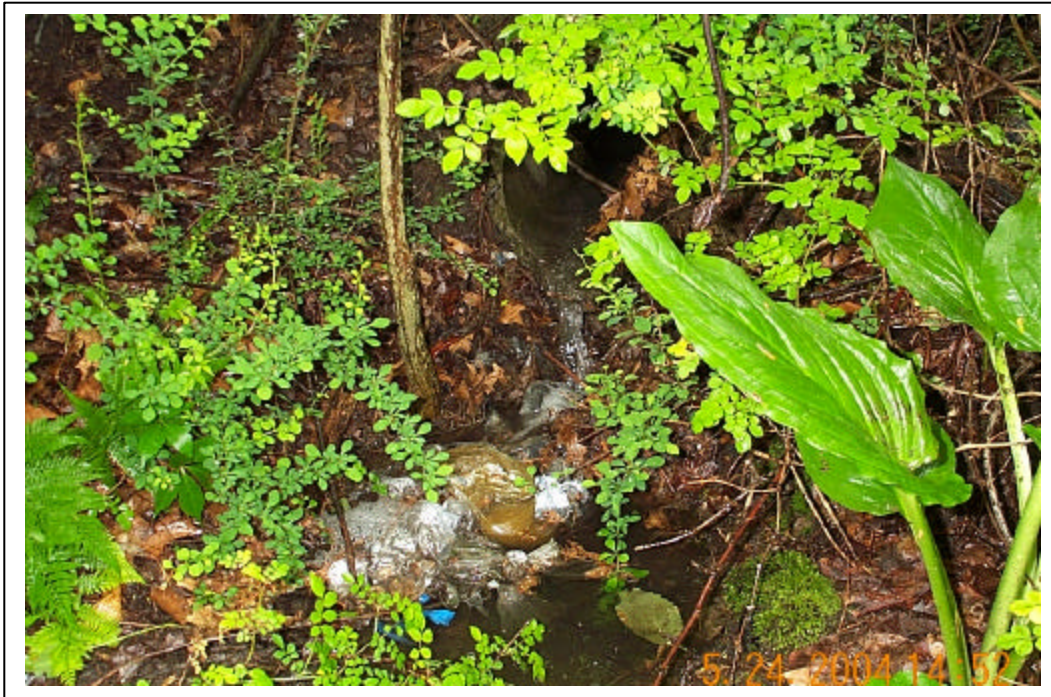
- **Belknap Road (Figures 7, 8 and 9)**
In a neighborhood downstream from Callahan State Park numerous bags containing dog feces were found at a storm water outfall to Baiting Brook. Bags were traced through the storm drain system at least 3 blocks away. The bags originate from the neighborhood and not from the park. On one occasion 18 bags were retrieved from the storm water outfall for proper disposal. One month later approximately 40 bags caught in-stream and on the stream banks were picked up for proper disposal by DEP during a stream walk of one block.

Figure 7. Bags of dog feces at outfall on bank of Baiting Brook.

Results: Elevated bacteria counts in the Belknap Road area were attributed to numerous bags containing dog feces that were found at a storm water outfall to Baiting Brook. The bags were also observed in the contributing storm drain system's catch basins, and were visibly tracked through a residential neighborhood at least three blocks from the outfall.

Outcome: The local (Framingham) NPDES Phase II Stormwater Coordinator and watershed association were notified of the problem in the Belknap Road neighborhood. Storm drain stenciling and other outreach to the neighborhood was encouraged and the DFW Riverways Program stream-team coordinator was contacted to help facilitate a storm drain stenciling project in this neighborhood.

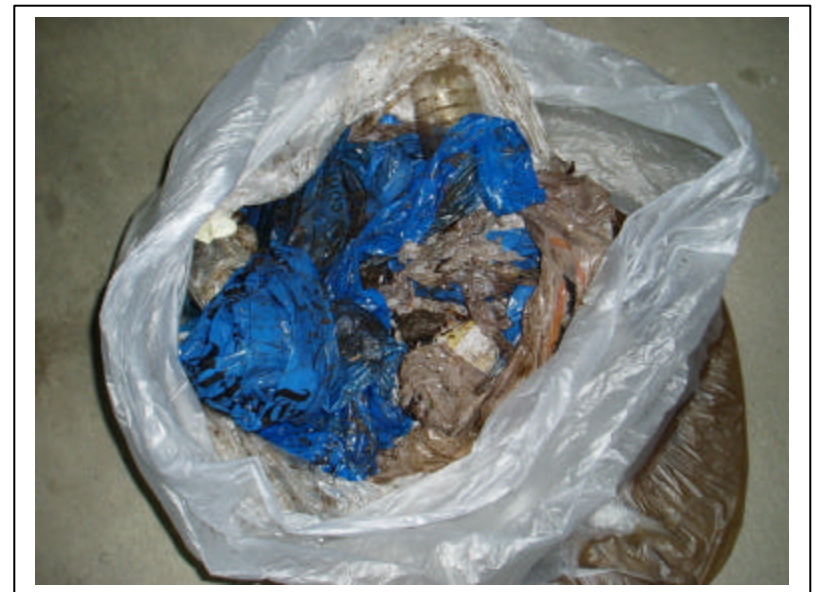
Figure 9. Dog bags collected from brook and on banks during 1 block stream walk.

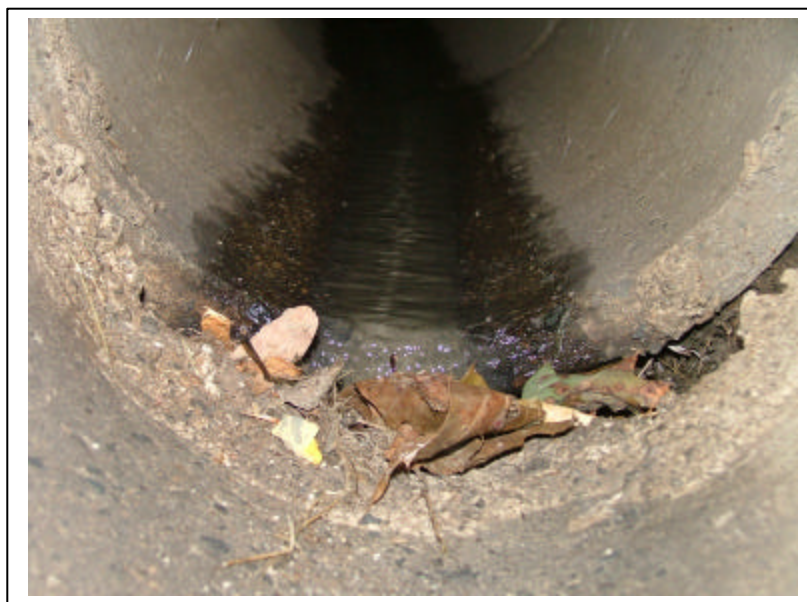
- **Mt. Wayte Avenue**
On the 6th sampling event at Mt. Wayte Avenue, closer examination of a storm water outfall revealed a dry weather discharge of raw sewage coming from a break in the outfall approximately 1 foot inside of the pipe (Figure 10). E. coli counts of the discharge were estimated at 2.9 million cfu/100ml. Sampling downstream from this outfall was discontinued, as it would not be possible to distinguish a 2nd source from this direct contamination.

Figure 10. Dry weather discharge to Eames Brook at Mt. Wayte Ave, Framingham.

Results: Source tracking activities located a dry weather flow of sewage from a storm water outfall flowing into Eames Brook. Sampling documented *E. coli* and fecal coliform counts in the millions as well as positive optical brightener tests. Sewage fungus was also observed growing on the streambed below the outfall.

Outcome: The Town of Framingham DPW and the DEP Northeast Regional Office (NERO) were notified. Framingham unsuccessfully attempted to correct the problem (believed to be a leaking sewer line overlaying the stormdrain). A model NON for the discharge of pollutants into a stormdrain was drafted by NERO based on this situation. It is expected that the town will correct the problem as a result of this action.
